Check-out Inventory Report

2 Brighton Street, Brighton, East
Sussex, England, BN1 1AB

TENANCY END DATE
11/03/2020

PREPARED ON BEHALF OF
Lemon Lettings

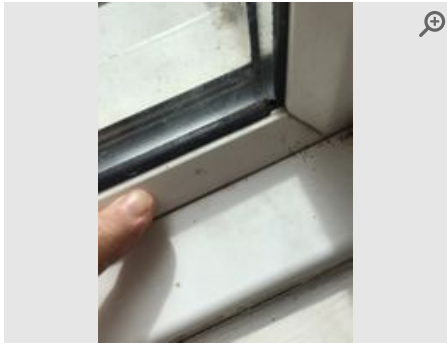
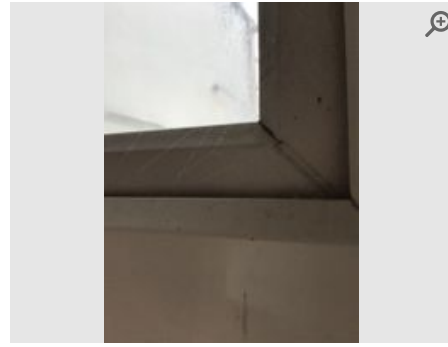
Entrance and Living room				
Item	Description	Condition	Cleanliness	Photos
Windows and Sills 1.1		● Fair	● Poor

2 photos
	Information provided by inspector: Frame is slightly grubby and dusty. Venetian blind clean and working.			
	! Tenant responsibility

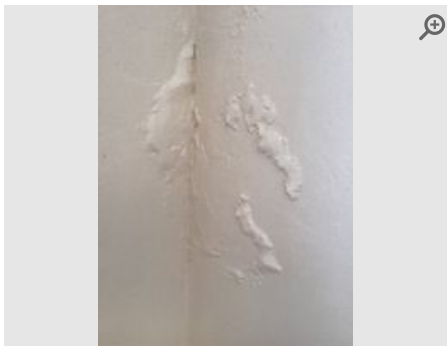
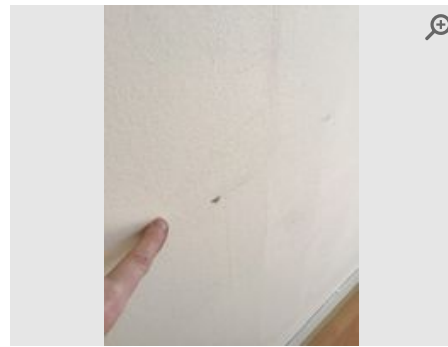
Clean			
Walls 1.2		● Fair	● Good

2 photos
	Information provided by inspector: Paint bubbling RHS of window. Water ingress damage? Needs investigating. Slightly scuffed by entrance-consistent with normal wear and tear.			
	🔧 Landlord responsibility

Repair			
Light Fittings 1.3	Bulb seen working	● Good	● Good

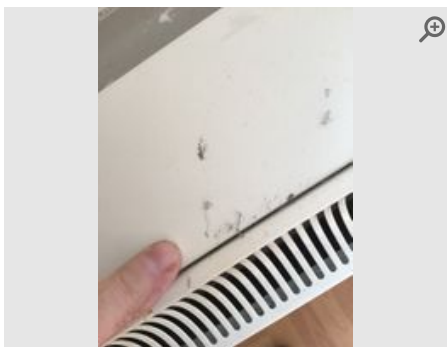
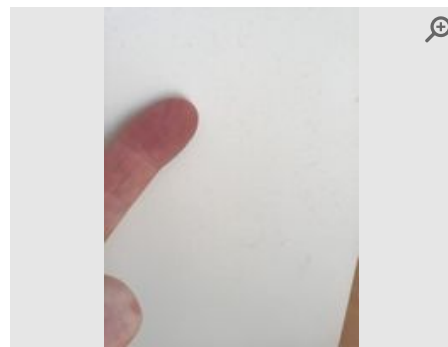
N/A
Radiator 1.4		● Good	● Poor

2 photos
	Information provided by inspector: Dusty to top and front.			
	! Tenant responsibility

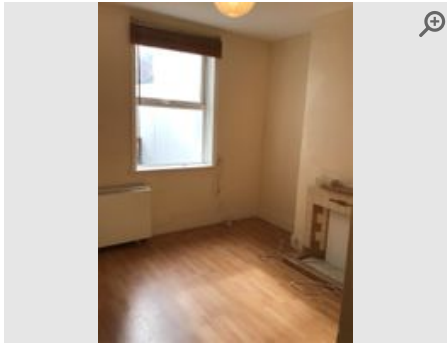
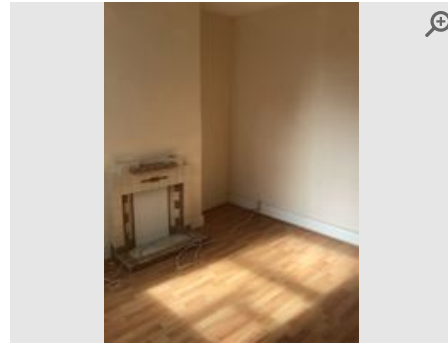
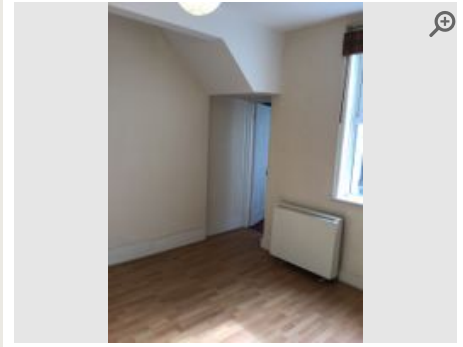
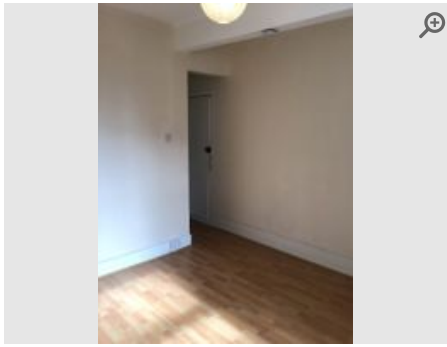
N/A
General Overview 1.6	Consistent with age Grubby window frame, dusty radiator. Bubbling paint to 1 corner-needs investigating.	● Fair	● Fair

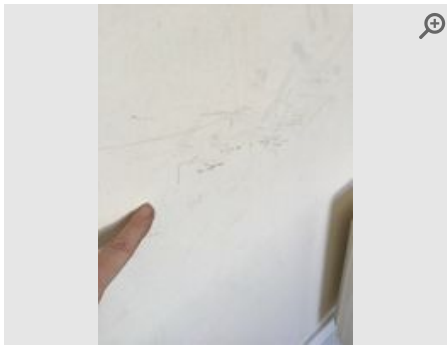
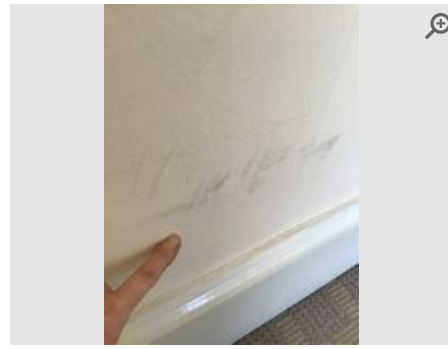
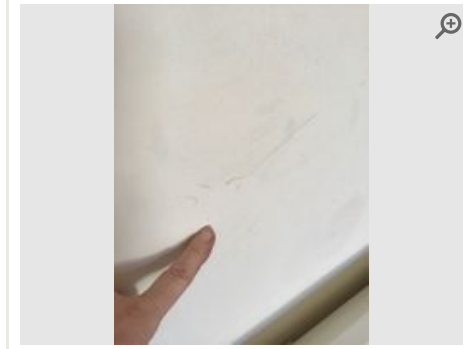
Item	Description	Condition	Cleanliness	Photos
Walls 2.1		● Fair	● Fair	📷 3 photos
	Information provided by inspector: Dark marks to lower level and above radiator to LHS wall upon entrance. Needs cleaning off/ painting over. Otherwise as inventory.			
	🚨 Tenant responsibility 🔧 Repair 🧼 Clean			
Floor 2.2		● Good	● Poor	📷 5 photos
	Information provided by inspector: Additional spot staining to centre and LHS in front of window.			
	🚨 Tenant responsibility 🧼 Clean			
Skirting Board 2.3		● Good	● Good	📷 N/A
	Information provided by inspector: Dusty.			
	🚨 Tenant responsibility 🧼 Clean			
Light Fittings 2.4		● Good	● Good	📷 N/A
	Information provided by inspector: Bulb seen working.			
Radiator 2.5		● Good	● Poor	📷 2 photos
	Information provided by inspector: Dusty			
	🚨 Tenant responsibility 🧼 Clean			
Fireplace 2.6		● Good	● Fair	📷 2 photos
	Information provided by inspector: Slightly dusty throughout. Marks to mantel piece.

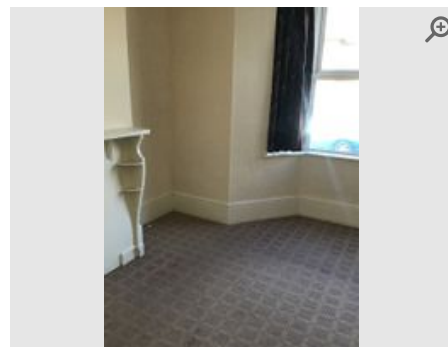
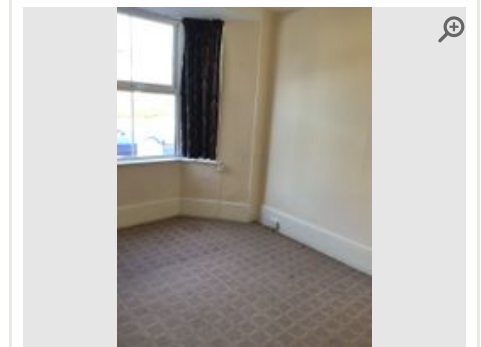
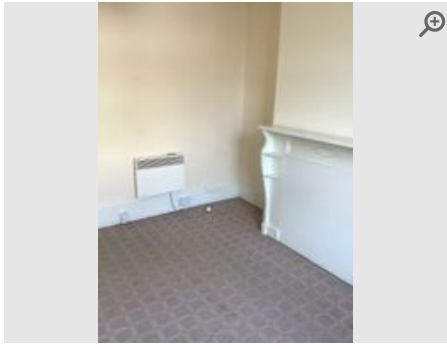
🚨 Tenant responsibility 🧼 Clean			
General Overview 2.7	Worn/Tired Stains to carpet. Dusty skirting, mantel piece and radiator. Otherwise as inventory.	● Fair	● Fair	📷 4 photos

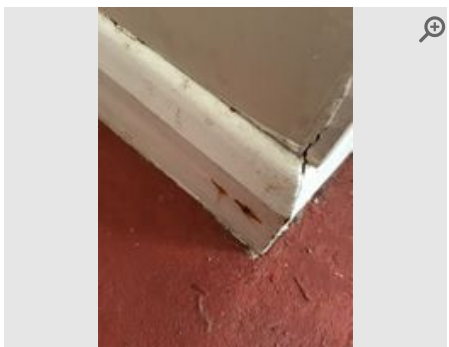
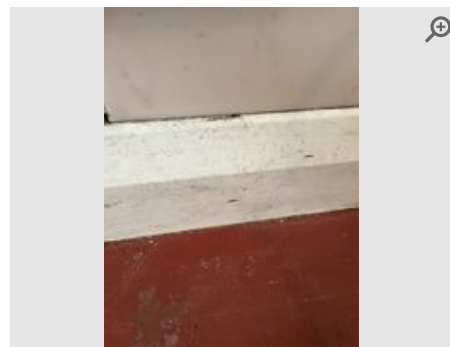
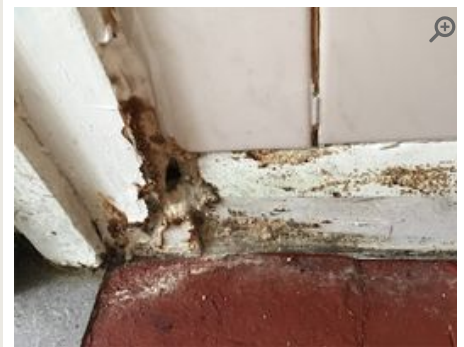
! Tenant responsibility Repair Clean			
Skirting Board 3.6		● Poor	● Poor	3 photos
	Information provided by inspector: Dusty and grubby throughout. Wood by bathroom entrance is starting to rot. Needs investigating by owner.			
	! Tenant responsibility Repair Clean			
Light Fittings 3.7	Bulb seen working	● Good	● Good	N/A
Radiator 3.8		● Good	● Poor	3 photos
	Information provided by inspector: Grubby marks and discolouration to front cover.			
	! Tenant responsibility Clean			
Kitchen Sink 3.9		● Fair	● Fair	2 photos
	Information provided by inspector: Slight limescale build up to drainer and base of taps. Needs cleaning off.			
	! Tenant responsibility Clean			
Kitchen Worksurfaces 3.10		● Fair	● Fair	1 photo
	Information provided by inspector: Heavy ring mark, otherwise as inventory			
	! Tenant responsibility Repair			
		● Fair	● Poor	6 photos

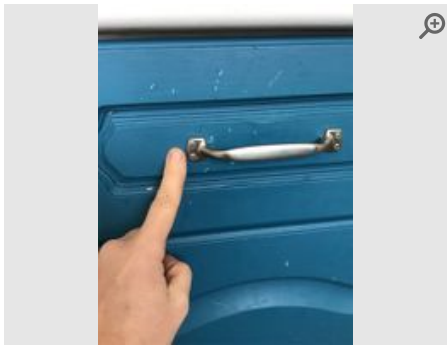
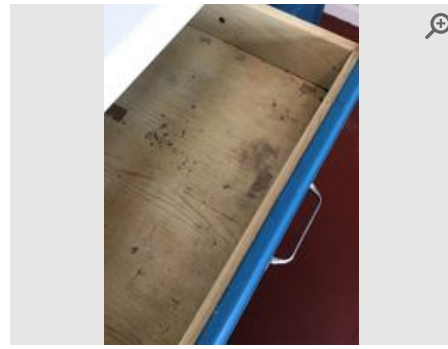
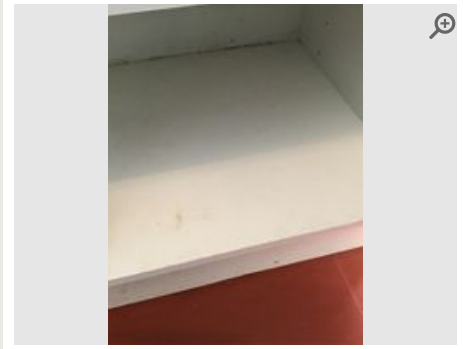
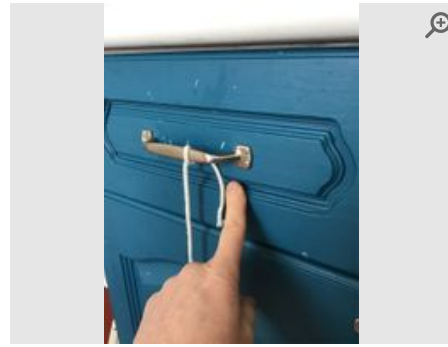
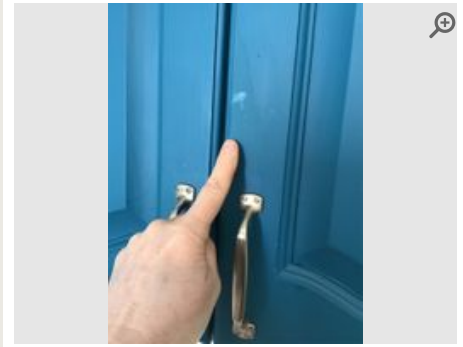
Kitchen Cupboards/Units

Kitchen Item	Description	Condition	Cleanliness	Photos
3.11 Cupboards/Units	<p>Information provided by inspector: Scratch marks (cat?) to base units by entrance door. Slight grease marks in places, exterior. Debris and stains to drawers, and base units interior.</p> <p>! Tenant responsibility</p>		<p>

Repair</p> <p>

Clean</p>	
3.12 General Overview	<p>Worn/Tired Dusty and grubby to wood work, units and floor. Floor heavily chipped in places, Skirting damaged by rot by bathroom entrance.</p>	<p>

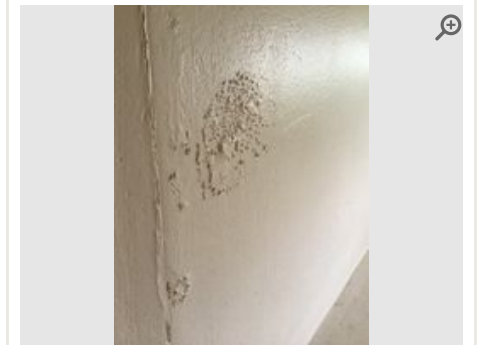
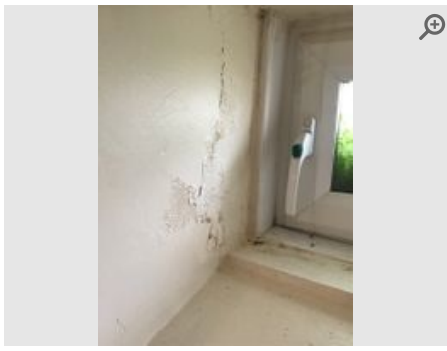
Item	Description	Condition	Cleanliness	Photos
Windows and Sills 4.1		● Poor	● Fair	📷 4 photos
	Information provided by inspector: Paint in window recess in bubbling and flaking.			
👉 Landlord responsibility		🔧 Repair		
Wall 4.2		● Fair	● Good	📷 1 photo
	Information provided by inspector: Dark mould/mildew patch under window. Needs investigating.			
👉 Landlord responsibility		🔧 Repair		
Floor 4.3		● Fair	● Poor	📷 2 photos
	Information provided by inspector: Debris/dusty throughout. Black square stain tomRHS corner.			
❗ Tenant responsibility		🧹 Clean		
Skirting Board 4.4		● Good	● Poor	📷 N/A
	Information provided by inspector: Dusty			
❗ Tenant responsibility		🧹 Clean		
Light Fittings 4.5		● Good	● Fair	📷 N/A
	Information provided by inspector: All bulbs seen working. Light shades dusty.			
❗ Tenant responsibility		🧹 Clean		
Safety 4.6	Smoke alarm heard working	● Good	● Good	📷 N/A
General Overview 4.7	Mould/mildew stain to front wall. Paint bubbling and flaking to recess by window. Carpet stained and dusty/debris. Skirting dusty. Otherwise as inventory.	● Fair	● Poor	📷 5 photos

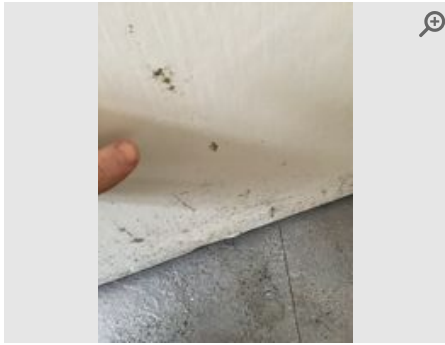
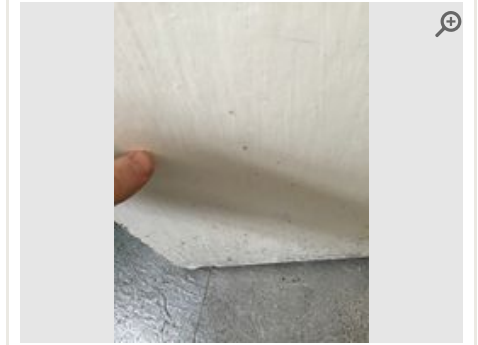
Item	Description	Condition	Cleanliness	Photos
Door (Internal) 5.1		● Fair	● Fair	3 photos
	Information provided by inspector: Dark grubby marks to bottom at exterior. Handles are scratched and tarnished.			
	! Tenant responsibility		Repair Clean	
Windows and Sills 5.2		● Good	● Fair	1 photo
	Information provided by inspector: Slightly grubby to frame in places.			
	! Tenant responsibility		Clean	
Walls 5.3		● Fair	● Fair	1 photo
	Information provided by inspector: Mildew marks to wall above toilet. era needs investigating. Paint bubbling in same area, as mentioned on inventory.			
	! Landlord responsibility		Repair	
Floor 5.4		● Fair	● Poor	2 photos
	Information provided by inspector: Slightly grubby and dusty.			
	! Tenant responsibility		Clean	
Skirting Board 5.5		● Fair	● Poor	1 photo
	Information provided by inspector: Grubby and dusty			
	! Tenant responsibility		Clean	
Light Fittings 5.6		● Good	● Fair	N/A

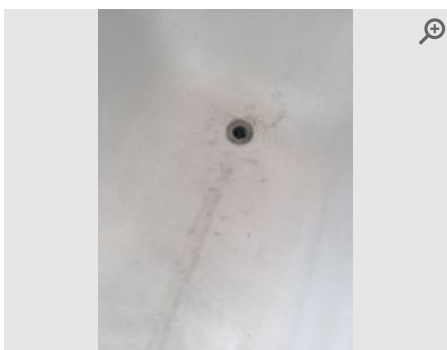
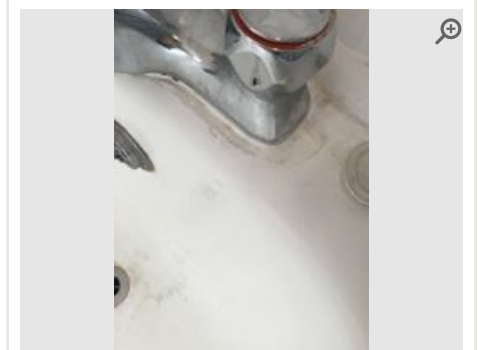
Information provided by inspector: Bulbs seen working. Dusty by batten fix.			
	! Tenant responsibility		Clean	
Bath 5.7		● Poor	● Poor	4 photos
	Information provided by inspector: Debris and marks throughout the bottom of bathtub.			
	! Tenant responsibility		Clean	
Toilet 5.8		● Fair	● Poor	3 photos
	Information provided by inspector: Dark staining under waterline. Grubby throughout.			
	! Tenant responsibility		Clean	
Items 5.9		● Good	● Good	N/A
	Information provided by inspector: Wall mounted mirror is dusty. Boiler-clean to front face.			
	! Tenant responsibility		Clean	
General Overview 5.10	Worn/Tired Toilet and bathtub stained and grubby. Floor slightly grubby/dusty. Stains to door exterior. Otherwise as inventory.	● Fair	● Fair	7 photos

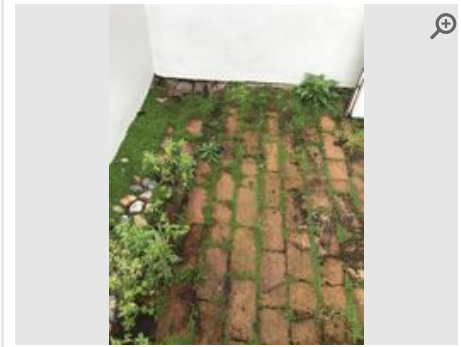
Patio at back

Item	Description	Condition	Cleanliness	Photos
Overview (External) 6.1		● Poor	● Poor	📷 5 photos
	Information provided by inspector: Weed growth in between tiles and at edges. Rubbish left.			
	! Tenant responsibility			🧹 Clean
