Check-out Inventory Report

2 Brighton Street, Brighton, East
Sussex, England, BN1 1AB

TENANCY END DATE
11/03/2020

PREPARED ON BEHALF OF
Lemon Lettings

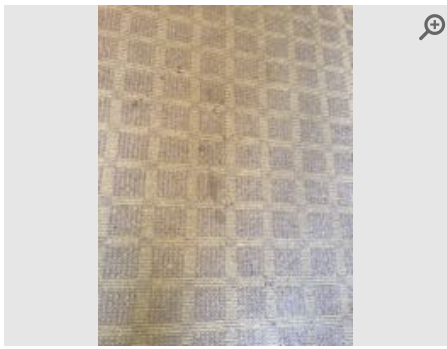
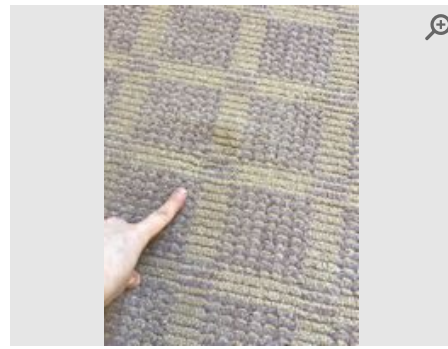
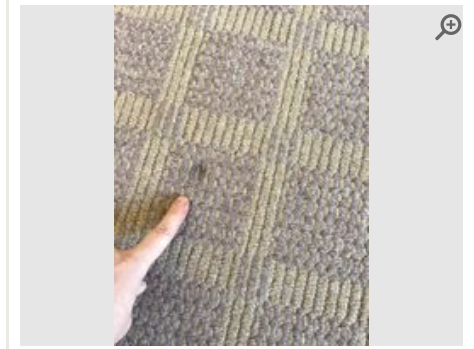
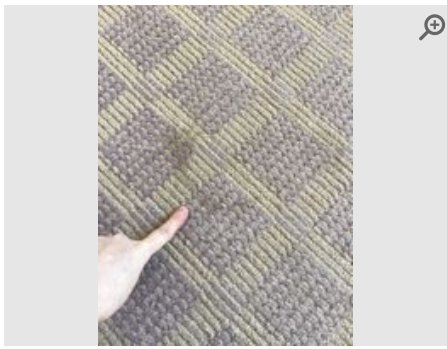
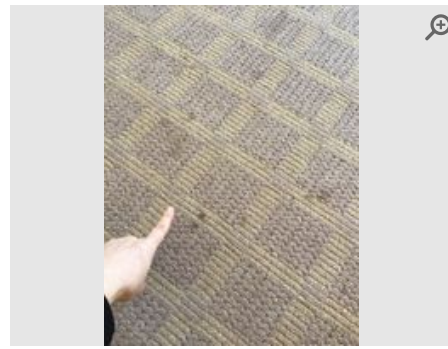
Floor

🚨 Tenant responsibility 🧼 Clean			
General Overview 2.7	Worn/Tired Stains to carpet. Dusty skirting, mantel piece and radiator. Otherwise as inventory.	● Fair	● Fair	📷 4 photos

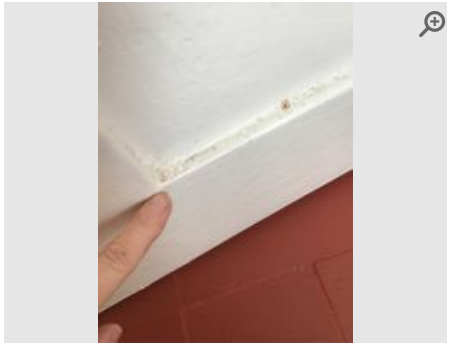
**Door
(Internal)**

Item	Description	Condition	Cleanliness	Photos
Door (Internal) 3.1		● Fair	● Fair	1 photo
	Information provided by inspector: Dusty to panels.			
	! Tenant responsibility Clean			
Patio Doors 3.2		● Good	● Poor	4 photos
	Information provided by inspector: Frame l'd grubby throughout.			
	! Tenant responsibility Clean			
Windows and Sills 3.3		● Fair	● Fair	3 photos
	Information provided by inspector: Tile cracked to sill. Frame slightly grubby.			
	! Tenant responsibility Repair Clean			
Walls 3.4		● Fair	● Poor	4 photos
	Information provided by inspector: Paint flaking against bathroom wall. Needs investigating and repainting. 3 nails. Piece of tile missing in recess area. Wall here very grubby and stained. Tile needs replacing/fixing. Area needs a clean.			
	! Tenant responsibility Repair Clean			
Floor 3.5		● Poor	● Poor	4 photos
	Information provided by inspector: Grubby marks. Heavily chipped by patio door and to front wall.

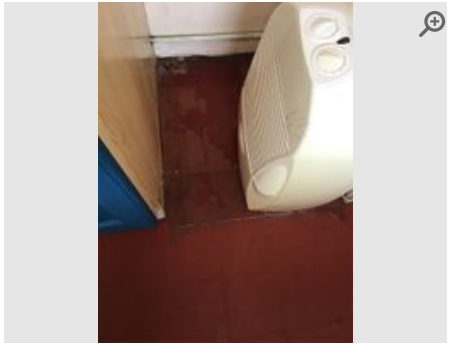
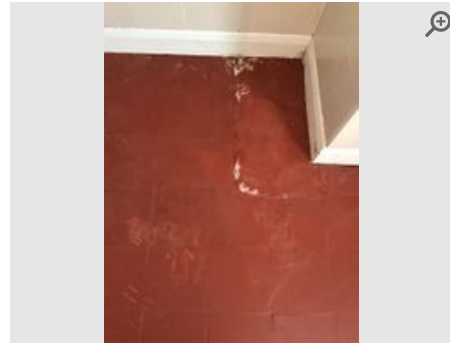
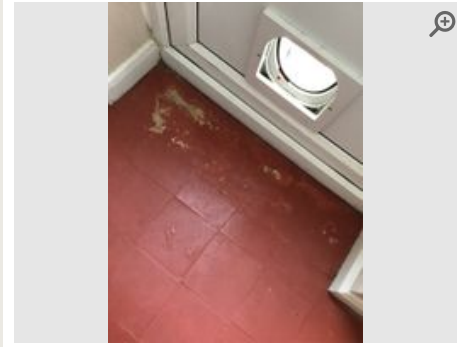
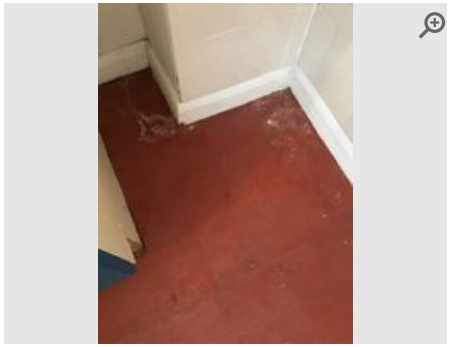
Clean</p>	
3.12 General Overview	<p>Worn/Tired Dusty and grubby to wood work, units and floor. Floor heavily chipped in places, Skirting damaged by rot by bathroom entrance.</p>	<p>

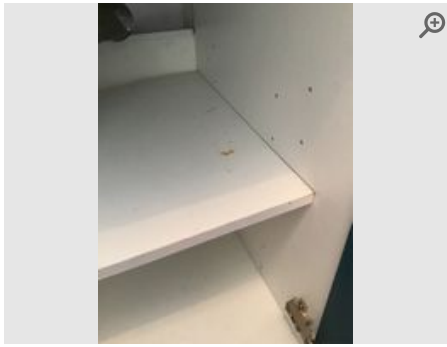
Kitchen Cupboards/Units

Kitchen Item	Description	Condition	Cleanliness	Photos
3.11 Cupboards/Units	<p>Information provided by inspector: Scratch marks (cat?) to base units by entrance door. Slight grease marks in places, exterior. Debris and stains to drawers, and base units interior.</p> <p>! Tenant responsibility</p>		<p>

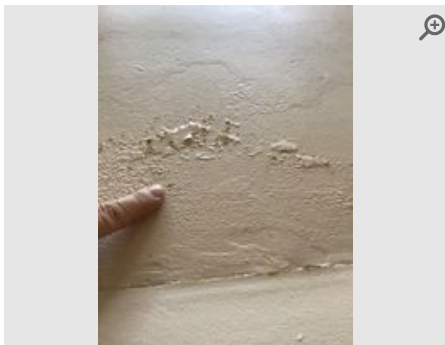
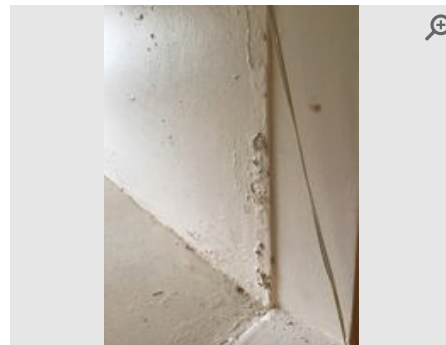
Item	Description	Condition	Cleanliness	Photos
Windows and Sills 4.1		● Poor	● Fair	📷 4 photos
	Information provided by inspector: Paint in window recess in bubbling and flaking.			
👉 Landlord responsibility		🔧 Repair		
Wall 4.2		● Fair	● Good	📷 1 photo
	Information provided by inspector: Dark mould/mildew patch under window. Needs investigating.			
👉 Landlord responsibility		🔧 Repair		
Floor 4.3		● Fair	● Poor	📷 2 photos
	Information provided by inspector: Debris/dusty throughout. Black square stain tomRHS corner.			
❗ Tenant responsibility		🧹 Clean		
Skirting Board 4.4		● Good	● Poor	📷 N/A
	Information provided by inspector: Dusty			
❗ Tenant responsibility		🧹 Clean		
Light Fittings 4.5		● Good	● Fair	📷 N/A
	Information provided by inspector: All bulbs seen working. Light shades dusty.			
❗ Tenant responsibility		🧹 Clean		
Safety 4.6	Smoke alarm heard working	● Good	● Good	📷 N/A
General Overview 4.7	Mould/mildew stain to front wall. Paint bubbling and flaking to recess by window. Carpet stained and dusty/debris. Skirting dusty. Otherwise as inventory.	● Fair	● Poor	📷 5 photos

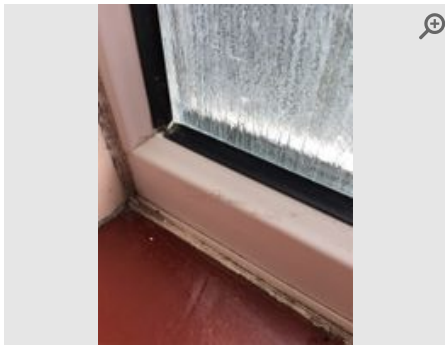
Item	Description	Condition	Cleanliness	Photos
Door (Internal) 5.1		● Fair	● Fair	3 photos
	Information provided by inspector: Dark grubby marks to bottom at exterior. Handles are scratched and tarnished.			
	! Tenant responsibility		Repair Clean	
Windows and Sills 5.2		● Good	● Fair	1 photo
	Information provided by inspector: Slightly grubby to frame in places.			
	! Tenant responsibility		Clean	
Walls 5.3		● Fair	● Fair	1 photo
	Information provided by inspector: Mildew marks to wall above toilet. era needs investigating. Paint bubbling in same area, as mentioned on inventory.			
	! Landlord responsibility		Repair	
Floor 5.4		● Fair	● Poor	2 photos
	Information provided by inspector: Slightly grubby and dusty.			
	! Tenant responsibility		Clean	
Skirting Board 5.5		● Fair	● Poor	1 photo
	Information provided by inspector: Grubby and dusty			
	! Tenant responsibility		Clean	
Light Fittings 5.6		● Good	● Fair	N/A

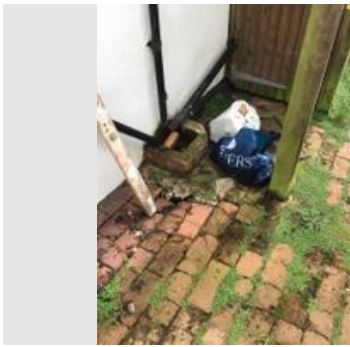
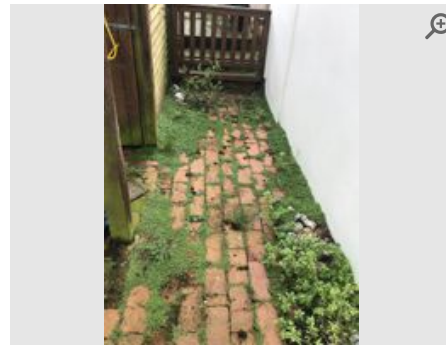
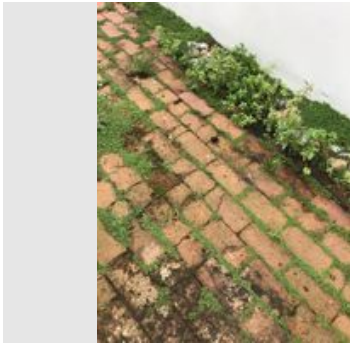
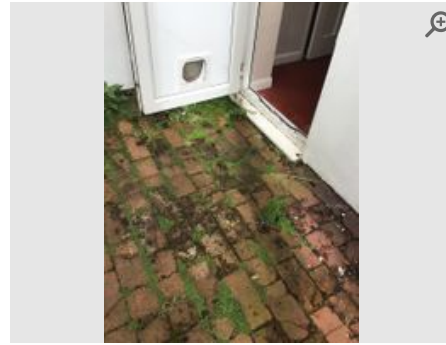
Item	Description	Condition	Cleanliness	Photos
Overview (External) 6.1		● Poor	● Poor	📷 5 photos
	Information provided by inspector: Weed growth in between tiles and at edges. Rubbish left.			
	! Tenant responsibility			🧹 Clean
